**Surface Radiological Investigations  
at White Wing Scrap Yard,  
Oak Ridge Reservation,  
Oak Ridge, Tennessee**

Date Issued—September 1991

OAK RIDGE NATIONAL LABORATORY  
Oak Ridge, Tennessee 37831-6285  
managed by  
MARTIN MARIETTA ENERGY SYSTEMS, INC.  
for the  
U.S. DEPARTMENT OF ENERGY  
under contract DE-AC05-84OR21400

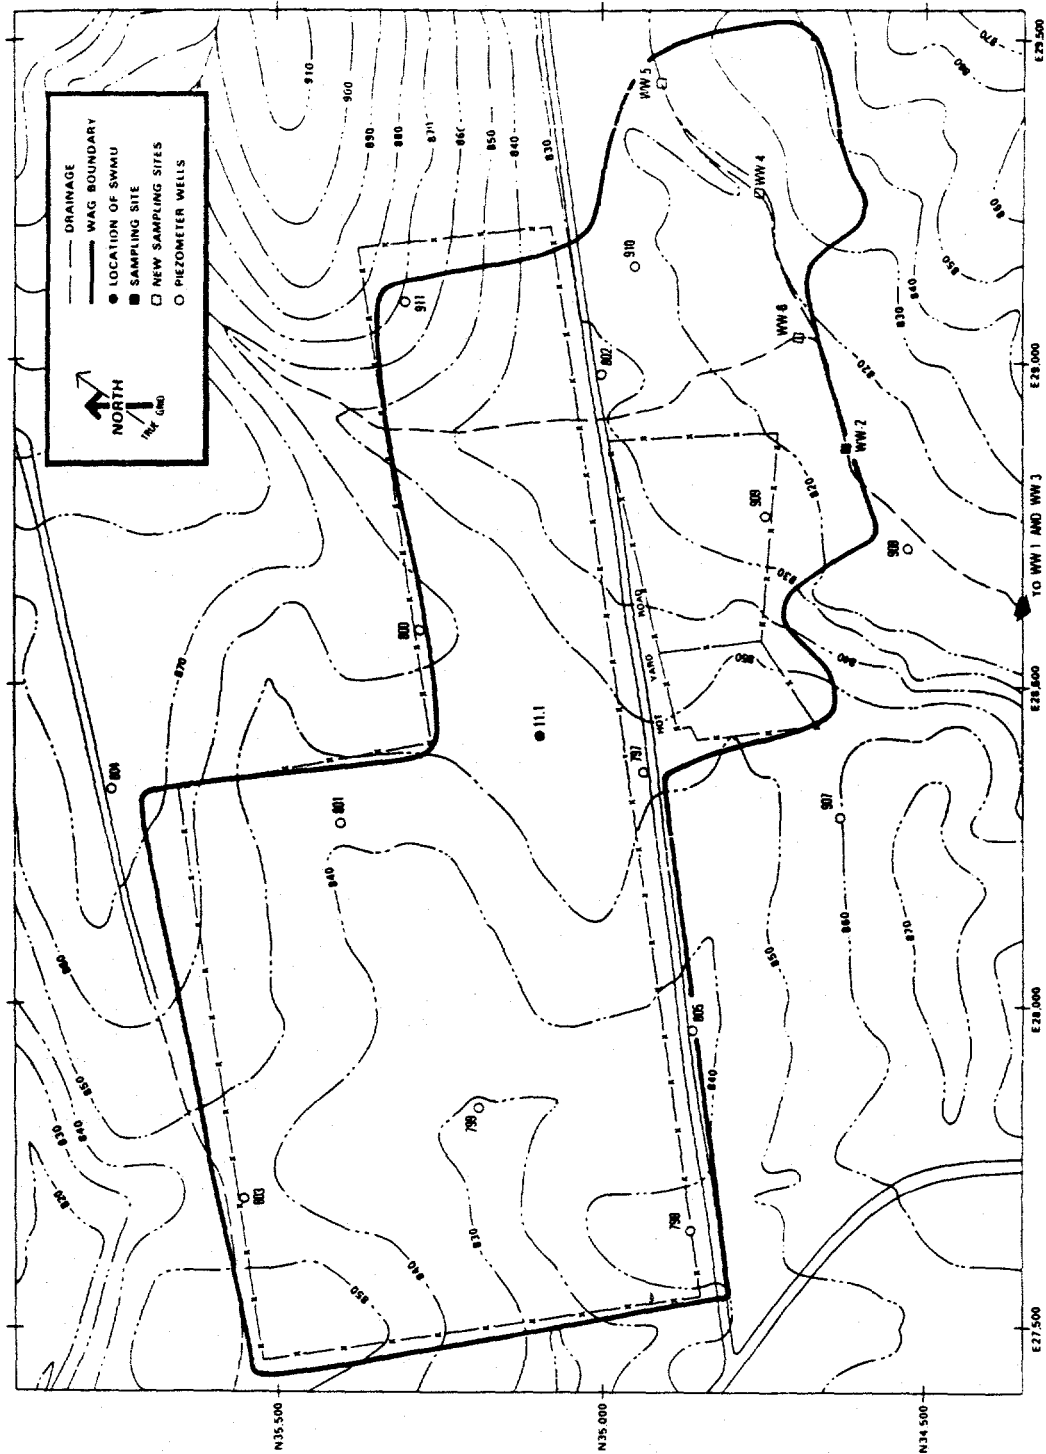
ORNL-DWG 88-9903

Fig. 2.2. Diagram of White Wing Scrap Yard (WAG 11).

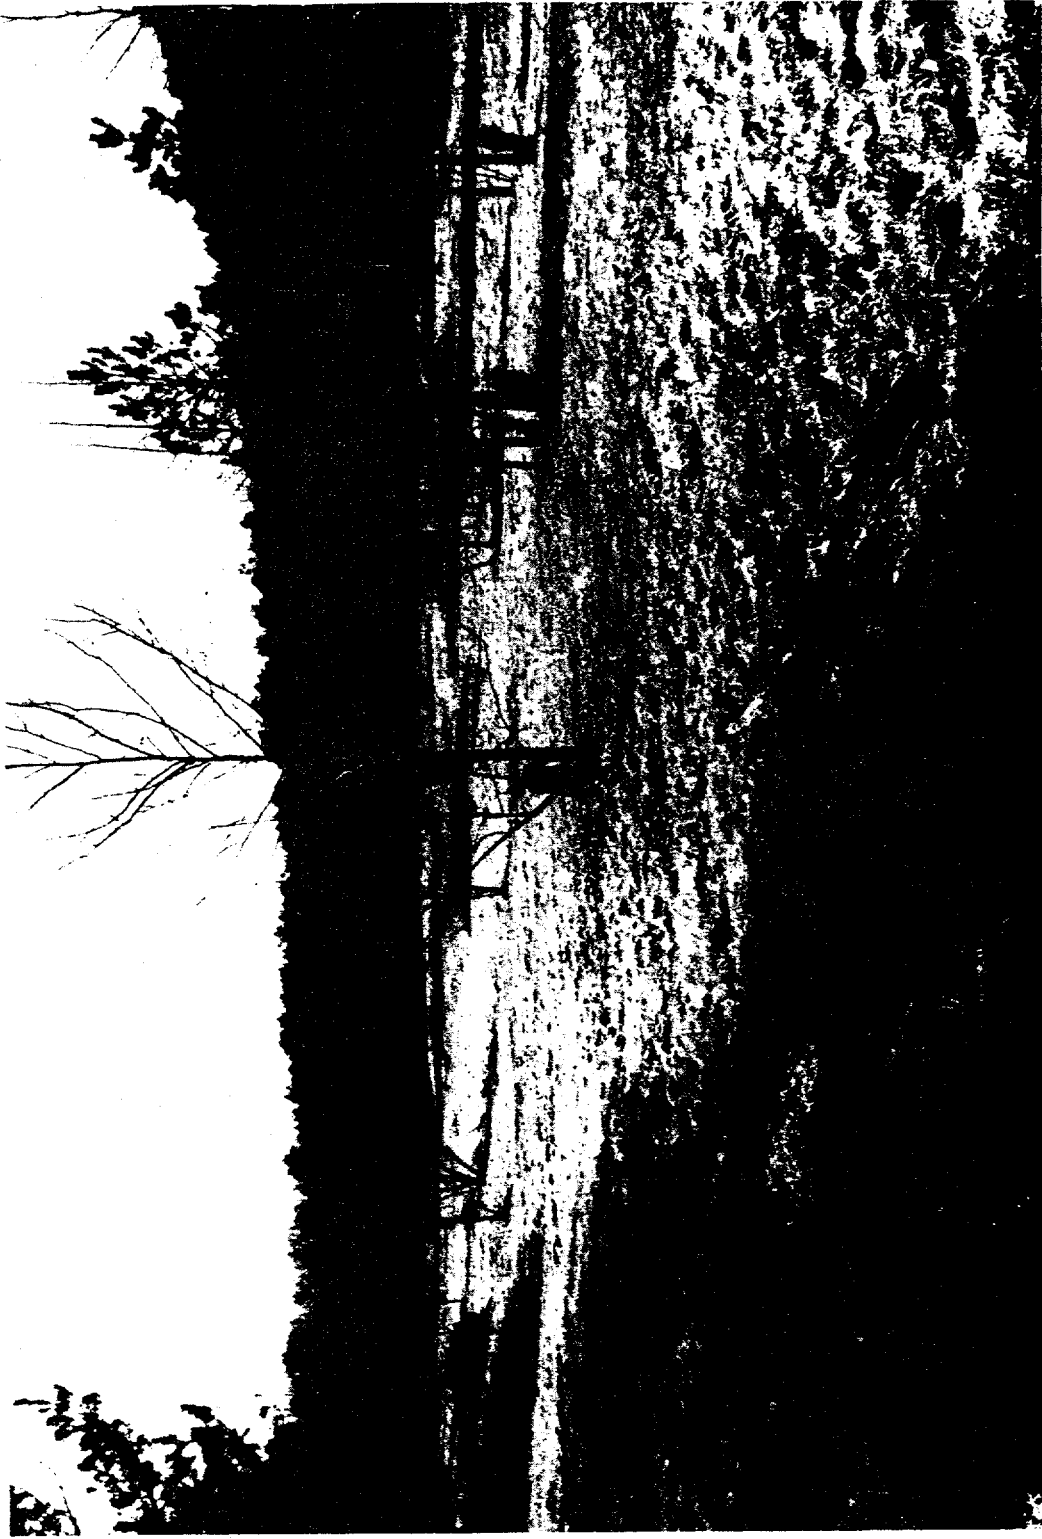
ORNL-PHOTO 402-90

Fig. 2.7. View looking west at large field where past aboveground storage of contaminated scrap occurred at the White Wing Scrap Yard site (January 1990). Reportedly this area was used by the K-25 Site.

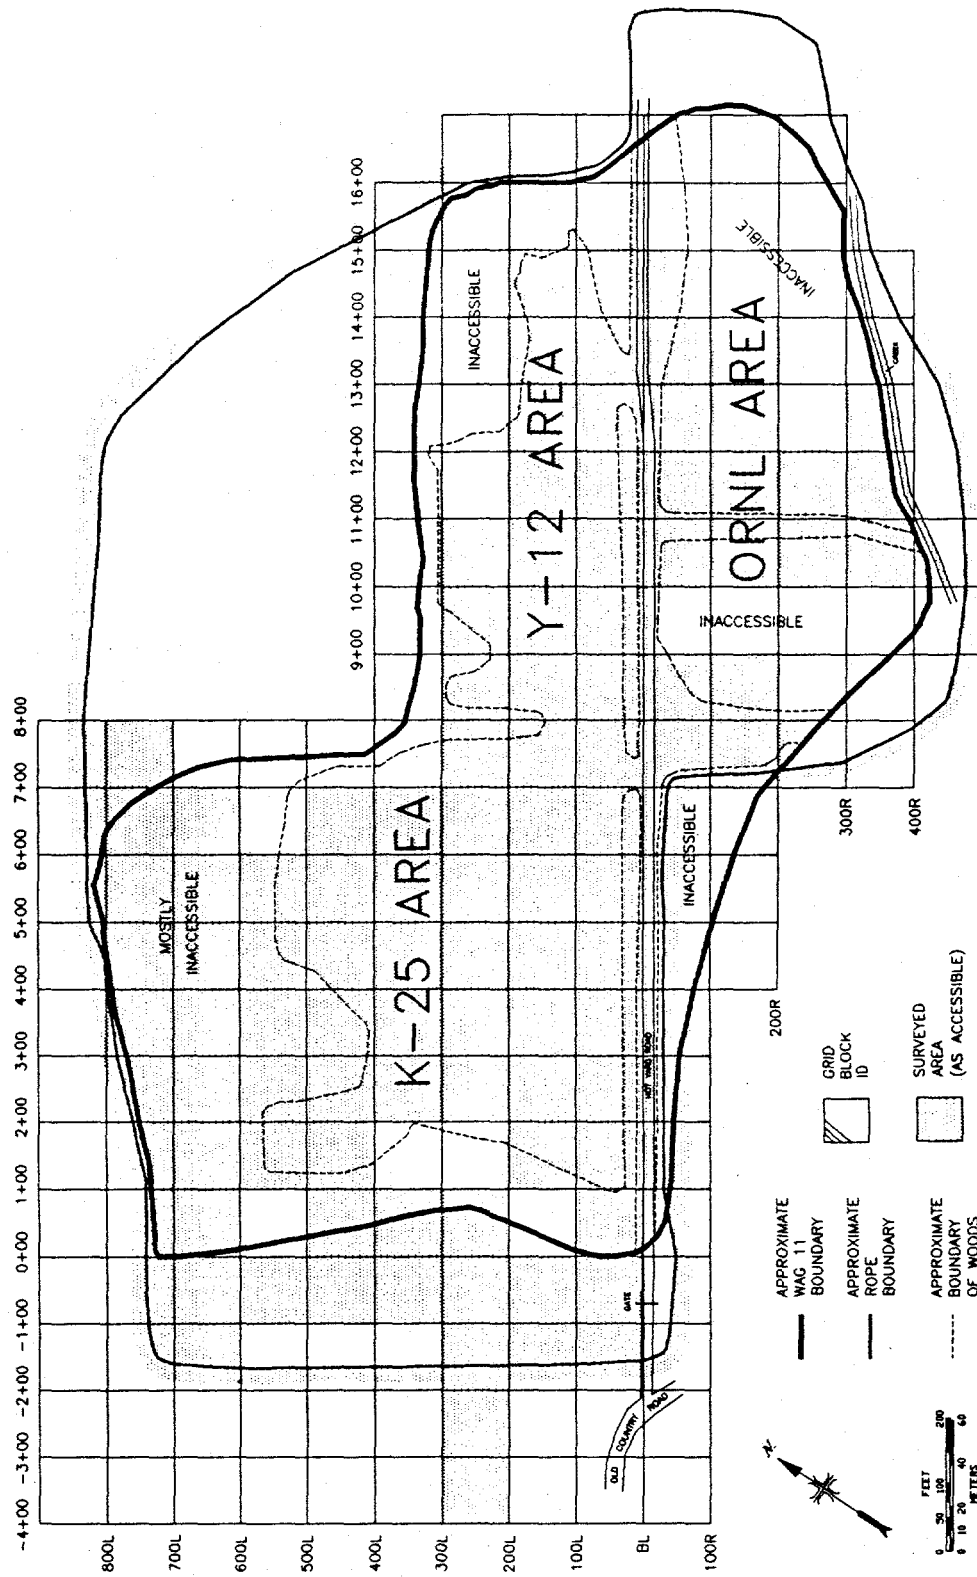
ORNL-DWG 91-14001

Fig. 3.1. Diagram showing grid block locations at the White Wing Scrap Yard site. Reportedly, the area north of Hot Yard Road was used by K-25 and Y-12, and the area south of the road was used by ORNL. Only accessible areas of the shaded grid blocks were surveyed.

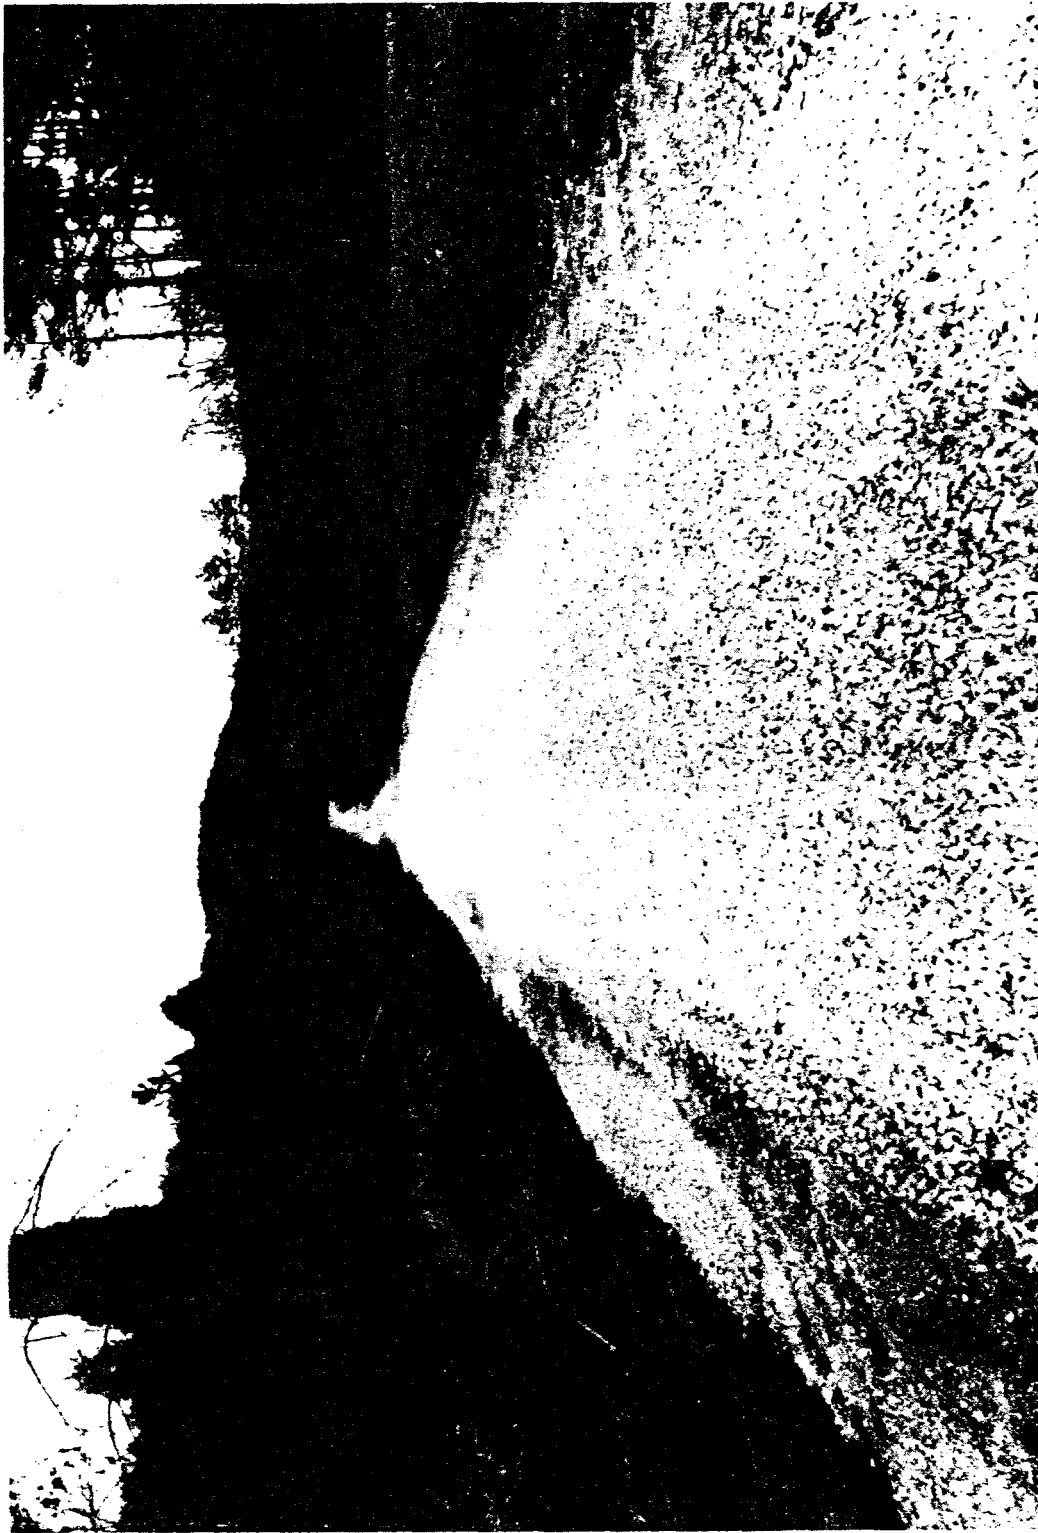
ORNL-PHOTO 385-90

Fig. 3.2. View looking east at Hot Yard Road at the White Wing Scrap Yard site (January 1990).

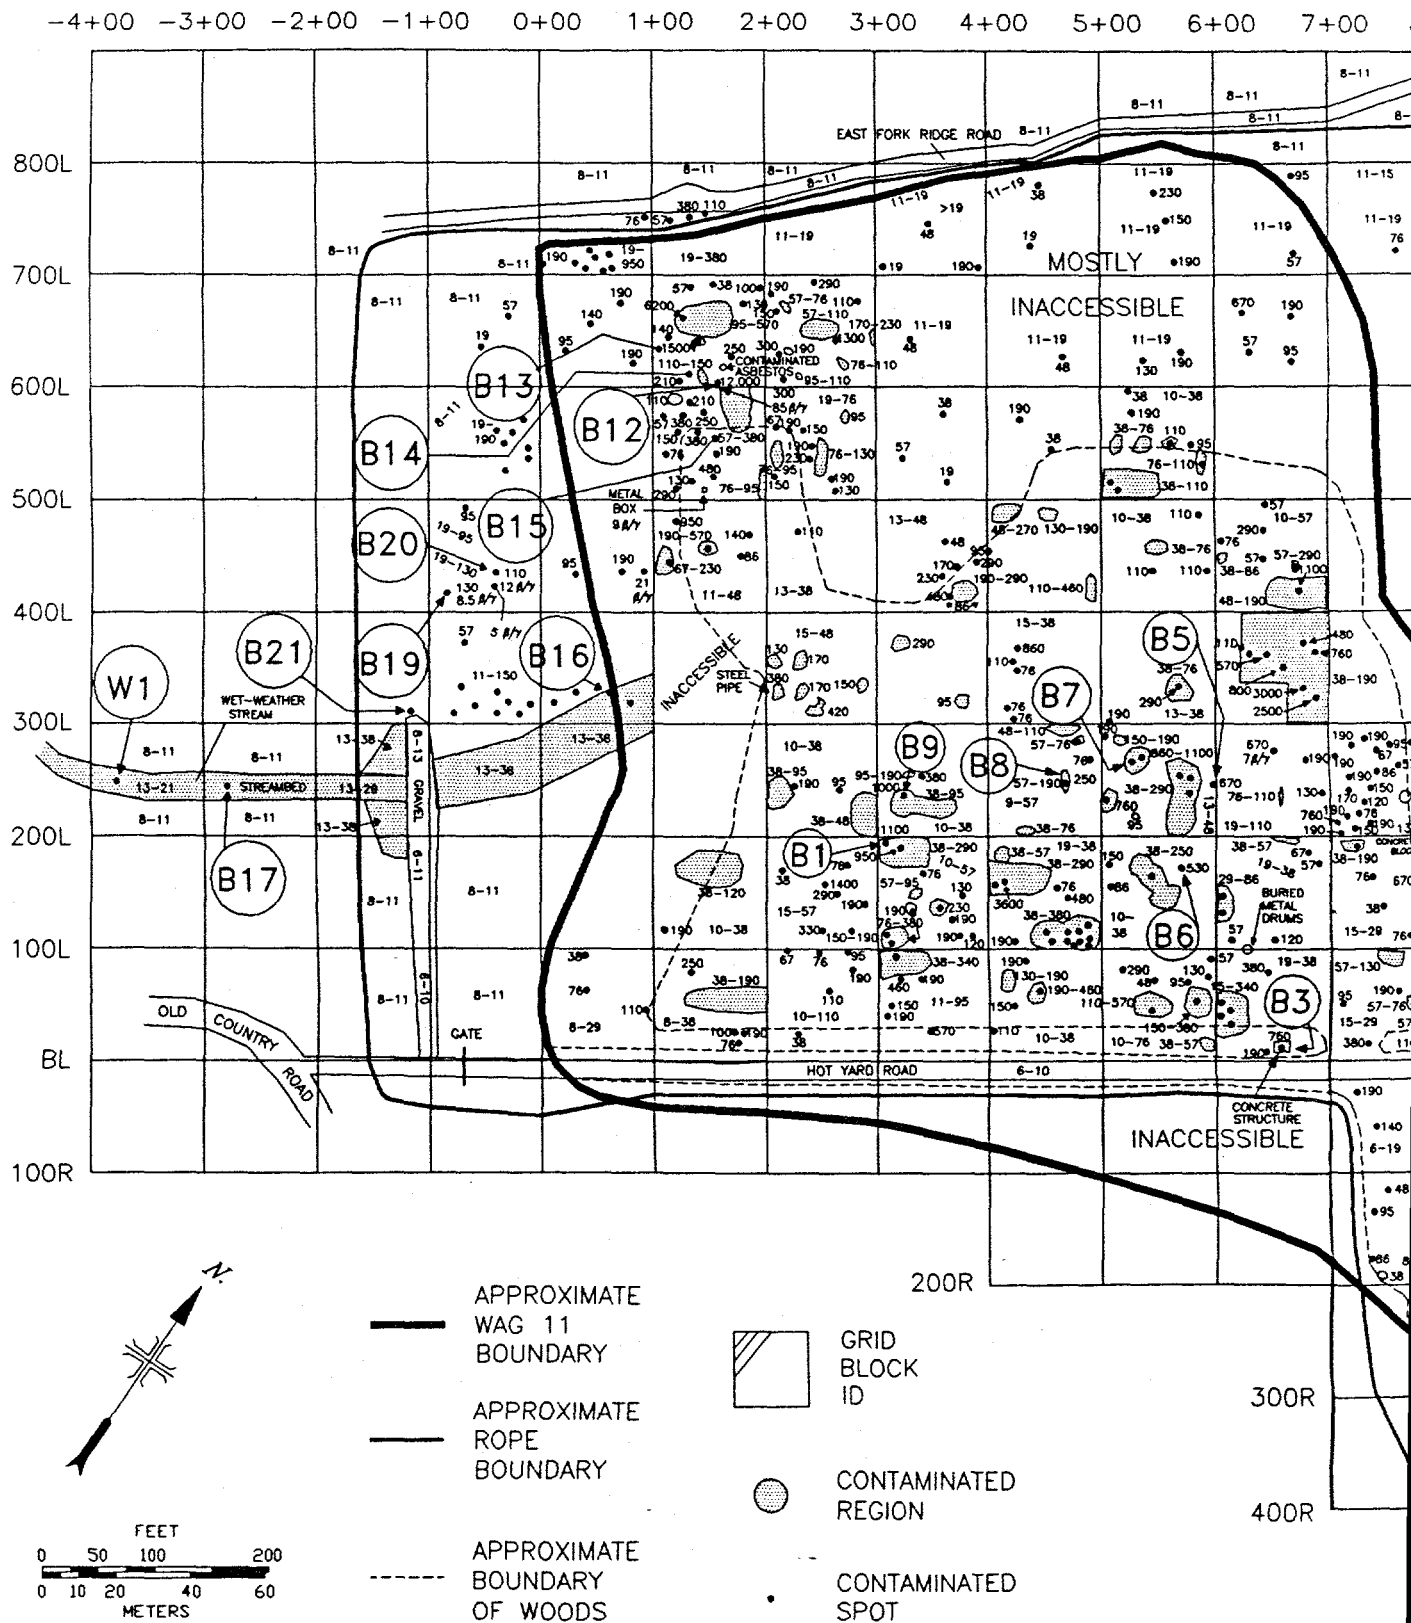
**Fig. 4.1. Regions of elevated surface gamma exposure rates ( $\mu\text{R/h}$ ), beta-gamma dose rates ( $\beta/\text{y}$ ) Scrap Yard site. Soil and water sampling locations are designated with B# and W#. Locations and numbers accessible areas of the site; wooded areas were generally inaccessible. Inaccessible areas within surveyed grid t**

Results of sample analysis show  $^{238}\text{U}$  and  $^{137}\text{Cs}$  to be the dominant radiological contaminants. The locations of sampling sites are shown in Fig. 4.1. The results of isotopic dilution/mass spectrometry of four samples (B1A, B1B, B4, and B5) show elevated concentrations of uranium enriched in the isotope  $^{235}\text{U}$  (see Table 4.3). The degree of enrichment was as high as 15 atomic percent  $^{235}\text{U}$  in sample B4. The concentration of total uranium was 0.22 g of uranium per gram of analyzed sample (B4). It should be noted that samples B1A and B1B appeared to be a soil/concrete/rock mixture, whereas B4 and B5 samples consisted of a fused slag/rock/metal matrix.

- A diagram of the radiological surface conditions of WAG 11, depicting current surface radiation levels including surface hot spots (such as Fig. 4.1), should be maintained, updated, and made readily available to authorized personnel requiring access into the scrap yard area. Consideration should be given to posting such information at a highly visible location on-site (e.g., west Hot Yard Road entrance). Instructions to contact responsible area personnel (e.g., ORNL Health Physics personnel and ORNL ERP) with current telephone numbers should be included.

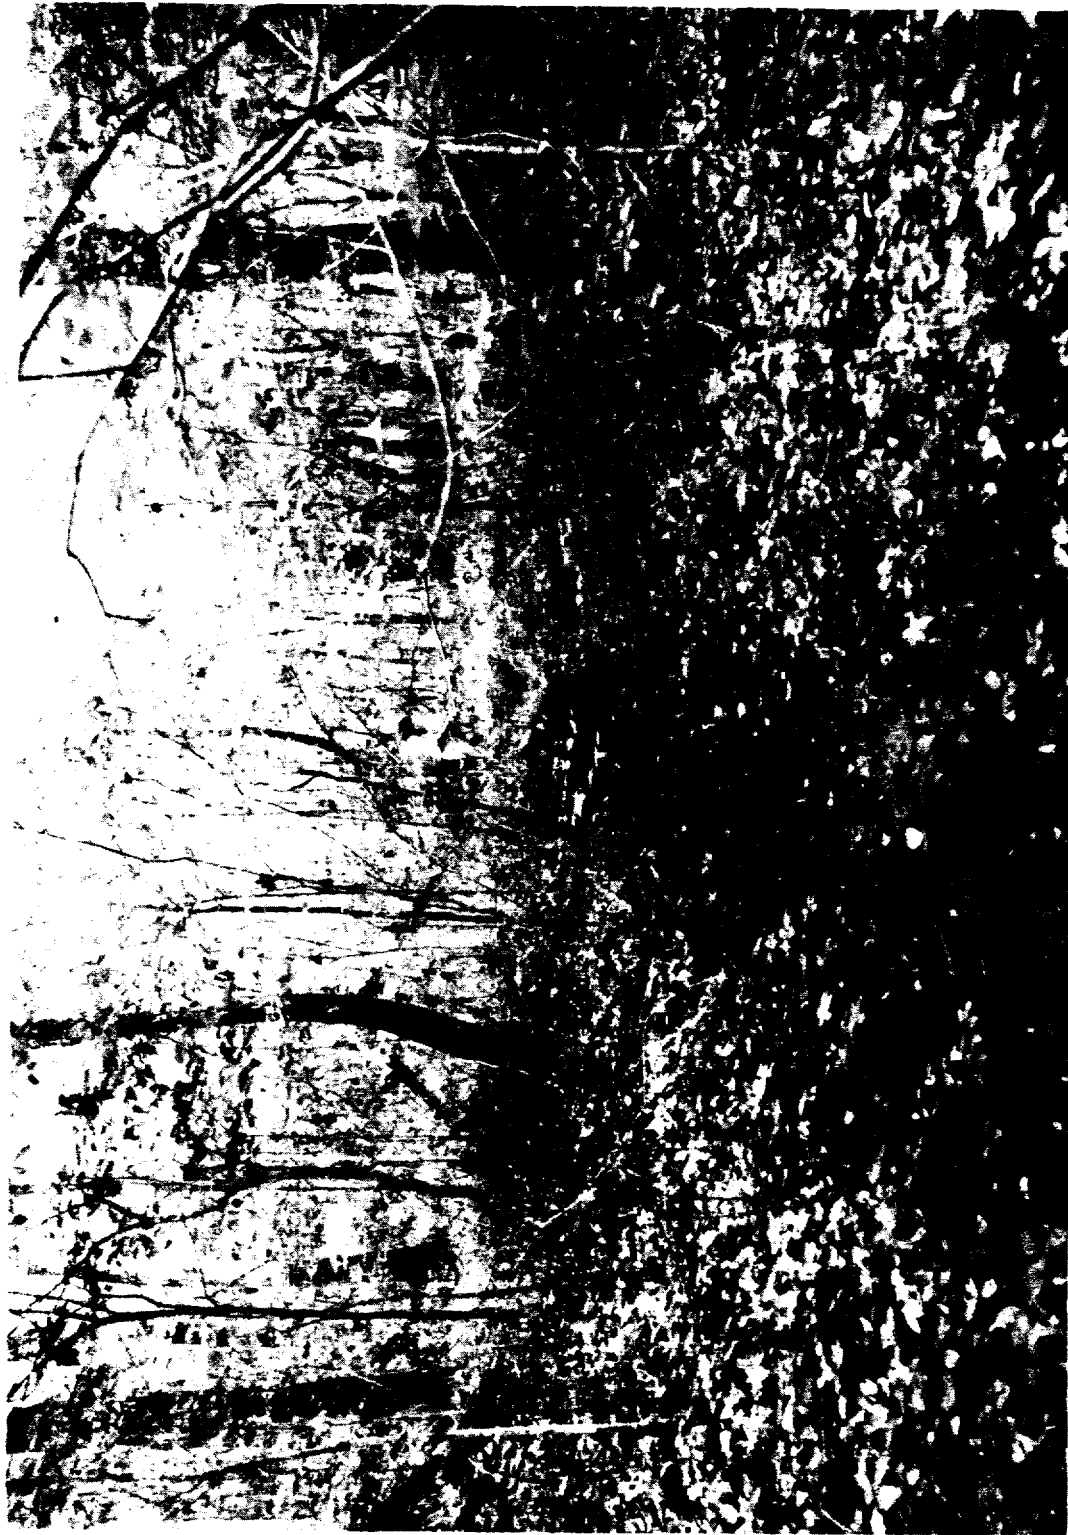
ORNL-PHOTO 7062-91

- Survey findings suggest the off-site migration of low levels of  $^{238}\text{U}$  by means of a wet-weather stream on the west side of WAG 11 (Fig. 5.2). At this location, outside of the WAG 11 rope boundary, gamma exposure rates of up to 29  $\mu\text{R/h}$  follow the ephemeral stream with contiguous contamination extending west beneath Old Country Road. A streambed soil sample and a water sample were collected approximately 120 ft and 220 ft, respectively, from the west rope boundary. Analytical results indicate no detectable radionuclide concentrations above typical background levels in the water sample; however,  $^{238}\text{U}$  concentrations of 100 pCi/g were measured in the streambed sample. For comparison purposes, surface soil concentrations of  $^{238}\text{U}$  in Tennessee range from 0.72 to 1.3 pCi/g and average 1.0 pCi/g.<sup>6</sup>

Fig. 5.2. View looking west at streambed of ephemeral stream with gamma exposure rates of up to 29  $\mu\text{R/h}$  located outside the WAG 11 rope boundary (July 1991).

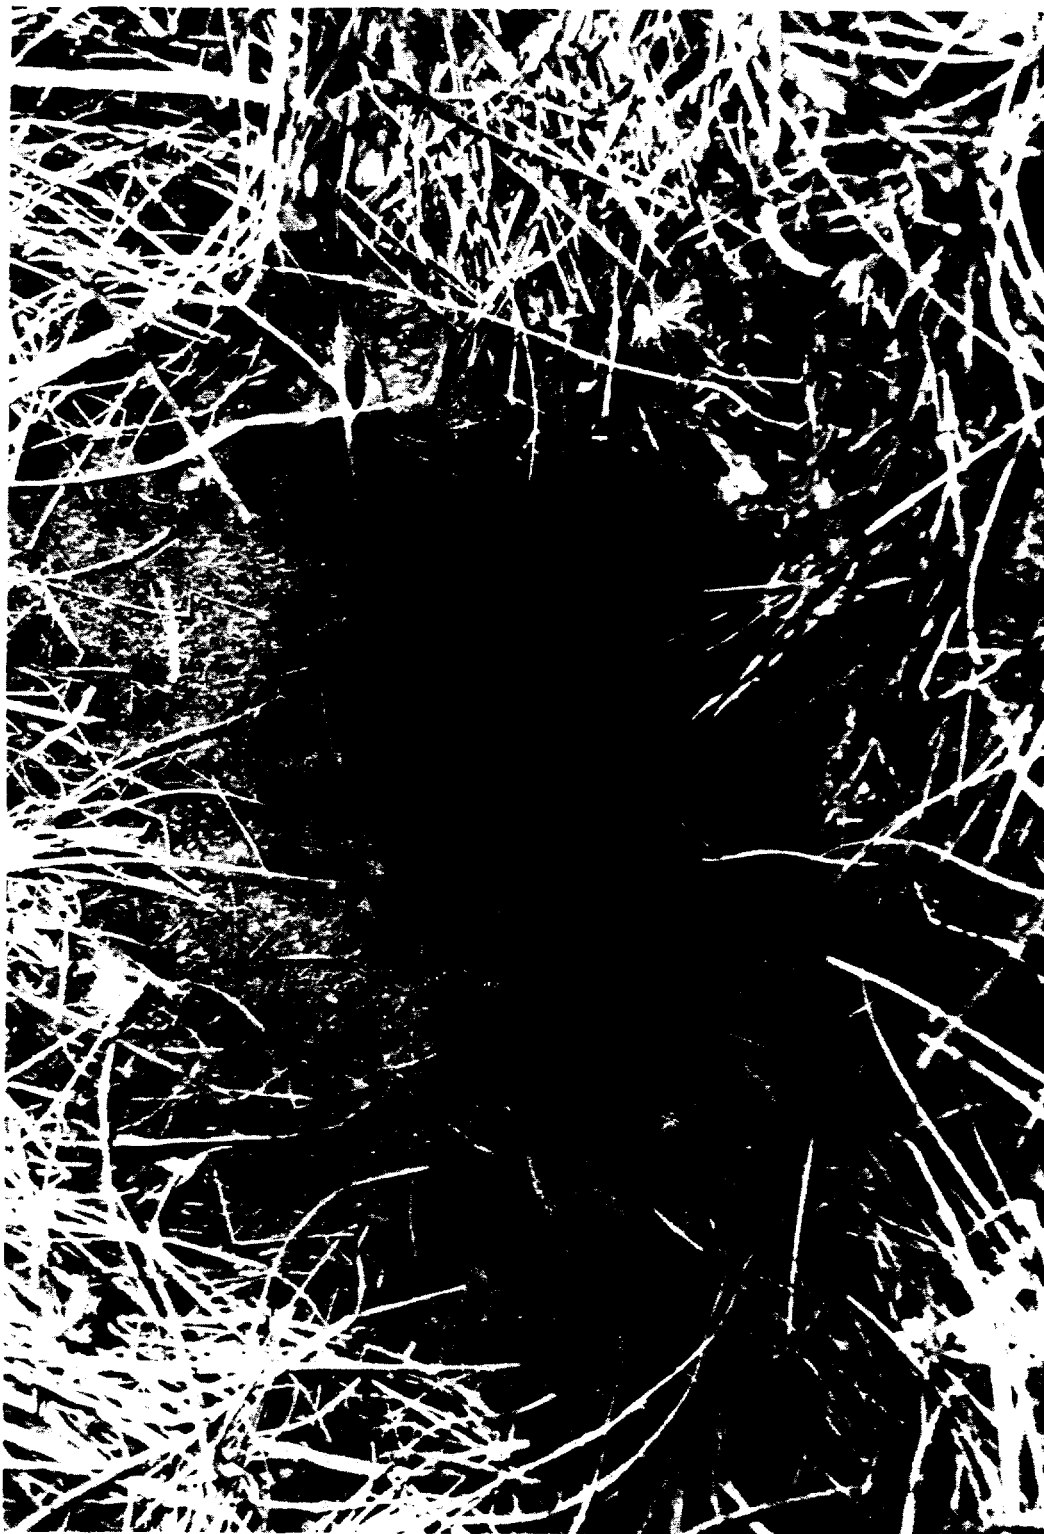
ORNL-PHOTO 404-90

- In a wooded area north of Hot Yard Road (grid location 6+14, 100L), a small ( $\sim 1\text{-m}^2$ ) area of surface subsidence (5 ft in depth) revealed portions of several buried, 55-gal metal drums (see Fig. 5.5). No significant elevation of beta-gamma dose rates was detected in the hole, although beta-gamma dose rates were slightly above typical background.
- Subsequent to preliminary findings of this survey, corrective measures involved the removal of several 55-gal metal drums found in the creek south of Hot Yard Road. A follow-up gamma scanning survey along the creek bank revealed two drums lodged in the creek bank soil. Gamma radiation measurements along the creek bank indicate generally typical background levels.

Fig. 5.5. View of ground-surface subsidence where buried metal drums were found at the White Wing Scrap Yard site (January 1990). Reportedly this region was used by the K-25 Site.

- Isolation procedures (i.e., roping) should be considered at the area of surface subsidence prior to mixed-waste analysis and subsequent verification of drum contents. Detailed subsurface characterization of this immediate area is recommended prior to drum removal. Additionally, radioactively contaminated metal drums found on the ground surface should be removed and disposed of in a designated radioactive waste disposal site. All drums found on site, particularly the few identified in the creek-bank area (south of Hot Yard Road), should be removed and properly disposed.
